The European Influence on the Ottoman Timber Residences in Istanbul

As most of the wooden houses of Arnavutköy were built in the first quarter of the 20th century, they reflect the architectural trends of those years. Besides the figures from the very popular movement Art Nouveau, eclectic decorations were also used intensely. Figures from western styles like neo-classic, neo-baroque and rococo are encountered as well as the oriental approaches.

The wooden building in Arnavutköy

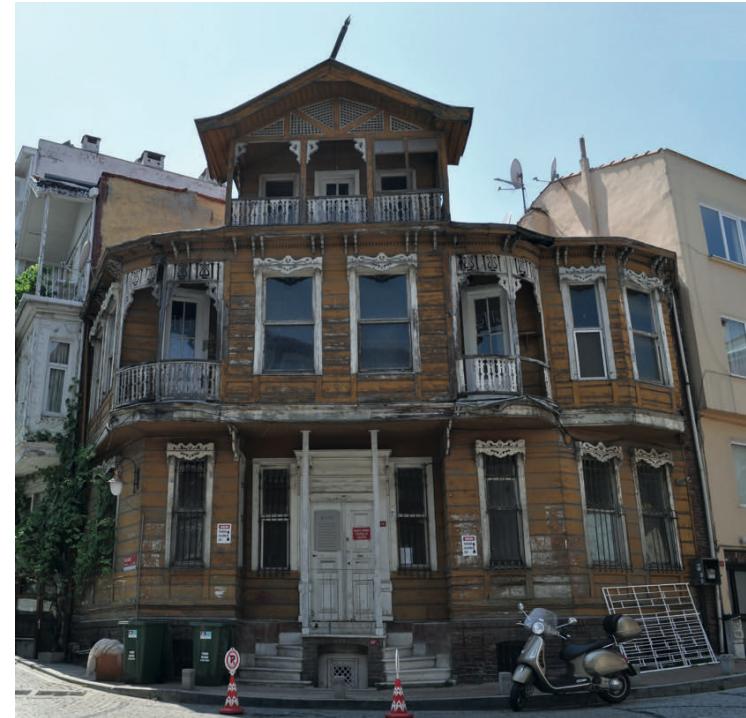
Figure 5.4: Street facades of the wooden house

The layout of the building enables the perception of the three street-facades of the house as one integrative monumental facade with angled surfaces (Figure 5.4). As the other two exterior walls are attached to the neighboring buildings, all the facade descriptions and drawings focus on the eye-catching street facades. About the attached facades, the northwest one is totally blind, while the west facade has one opening on each floor except basement. However, these windows are only for the basic needs and they are opened into a small well between the buildings.

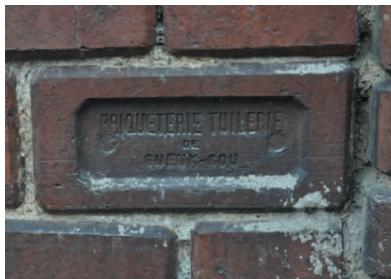
Figure 5.6: Brick with the original mark

Structural variation is reflected on the facade covering. Masonry basement floor is covered with brick, while timber is the coating material for all the upper floors. Brick fire wall, which became a mandatory application after the great fires in Istanbul, occupies 53 cm of the northeast facade. Dimensions of one single brick are approximately 20,5 x 9,5 x 6,5 cm and the original mark "BRIQUETERIE TUILERIE DE GUEUK-SOU" is visible on

some of the facade bricks (Figure 5.5). The stamp indicates the production of the Göksu brick and tile fabric, which was located in one of the Bosphorus villages, Göksu and opened in the late 19th century.

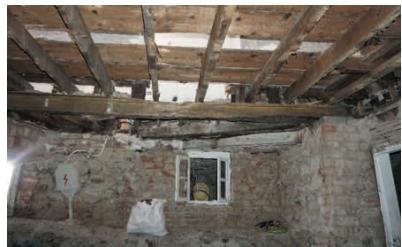
Figure 5.7: Basement Floor

Rough stone pieces and bricks are mainly visible from the interior on the current condition, but they might have been covered with plaster and color on the original utilization. White painted walls of the basement floor can be counted as an evidence supporting that assertion. Ceilings were also generally painted in white without any decoration. The jack arch system does not cover all the plan area, but it is easily recognizable on the ceiling of the hall (sofa) (Figure 5.7). It might be a later application to support. Height of the rooms and ceiling material varies. Except from the brick arched spaces, ceilings are covered by timber (Figure 5.8). The heights of the spaces were measured between 202-257 cm and it is written on the plan drawings room by room. Originally, floor was covered with terracotta tiles. They had to be taken during the restoration work. Therefore, the tiles are not found on the photos taken in 2015-2016.

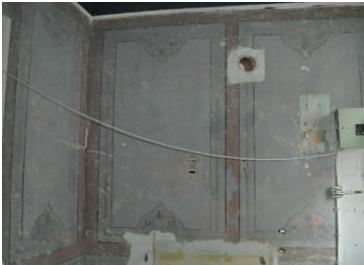
Figure 5.13: Hand drawings on the wall

Apart from the two masonry exterior walls, interior and exterior walls of these two floors are measured 18-19 cm. On nearly all of these walls hand-drawings are found for interior decoration (Figure 5.12). Flower motives and straight lines were sparsely used in a combination with vivid colors. Besides the hand-drawings, baseboards, ceiling corner moldings and decorated frames of the openings enrich the interior experience (Figure 5.14).

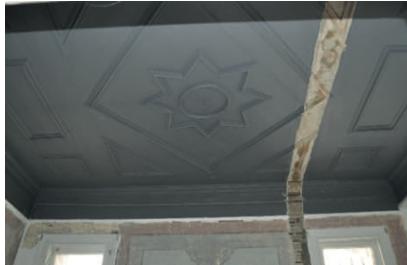
Figure 5.12: Ceiling decoration

All the ceilings of the both floors are covered with timber and each room has its own ceiling decoration in harmony with the plan as a common utility (Figure 5.13). In many of the traditional Turkish houses importance hierarchy of the rooms are reflected on the ceiling decorations. Usually, cantilever corner room of the first floor and the great hall are the most important spaces (Figure 5.16). In larger mansions, further rooms with special significance can be encountered. Correspondingly to the common tradition, three rooms have more attentive ceilings decorations, namely entrance hall of the ground floor (R_001), the space right above that hall (R_101) and the cantilever corner room of the first floor (R_103).

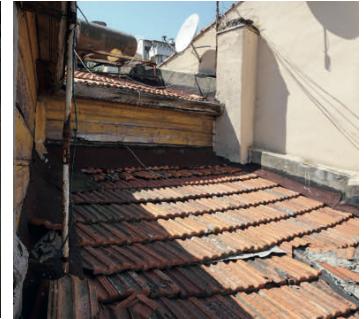
Figure 5.16: Leveled roof and the tiles

Second (Top) Floor: Usage area of the second floor is smaller than the other floors because of the leveled roof (Figure 5.17). The dashing mass on the top of the building is locally known as "cihannüma", which is generally described as a tower or garret with glass sufficient to see all around. This floor is also reached by the main and only interior stairs of the house. Identical with the other floors, the stairs come off to a hall (R_202). All the spaces are opened into this main hall. Due to the shape of the roof, two attics are out of the comfort living conditions and they are mainly for storage or technical controls. Each one is accessed via small door and the wooden structural elements like rafter and purlin are visible even from the doorsill. Bathroom of this floor is measured as 3,52 m² from interior and it is larger than the others on the down floors.

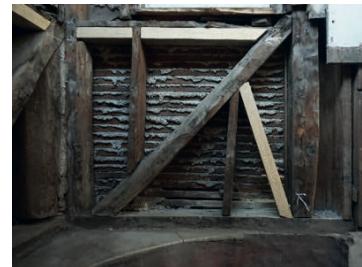
Figure 5.21: Structural elements from the ground floor wall

According to the hand measurements on site, width and height of the main load bearing posts, beams and braces are between 11-16 cm. Cross-section of the supporting studs and noggin are measured as approximately 4 x 12 cm and the plates under the flooring are around 3,5-5 x 12-17,5 cm. Floor thickness varies in each flat accordingly to the height of the floor joists. On the roof structure, rafters are around 11-13 x 3,5 - 4,5 cm and the top ridge board is nearly 5,5 x 18 cm. (Figure 5.21). Exact sizes of several wooden load bearing elements, 3D models and drawings of the structural system are given in the Drawings 17 to 21.

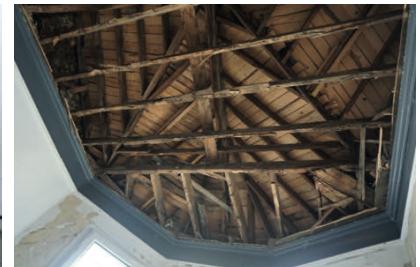
Figure 5.20: Ceiling of the room 103 and some part of the roof structure

Timber frame system is used without any infill. Load bearing posts made of oak are supported with plates and diagonal braces (Figure 5.20). In the same way, studs and noggin help to preserve the rigidity. The structural system is enveloped with horizontal timber boards from the outer side and "*bagdadi technique*" from the inner side. In this technique plaster is applied to thin horizontal timber laths with almost 0.5 to 1.5 cm thickness to create a clean-cut surface for the interior painting (also see Figure 5.18).

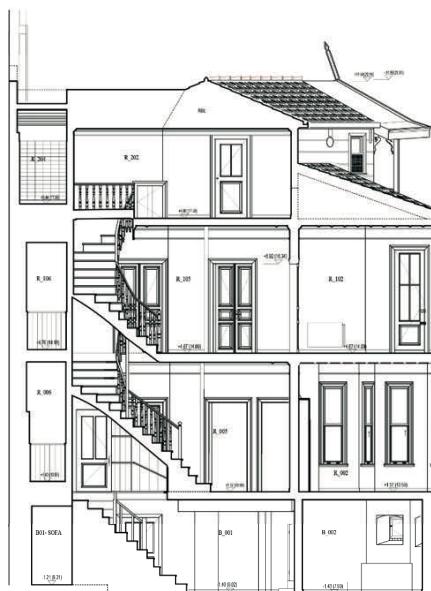
Drawing 5.5: Sections. Rearranged by the author based on the drawings of N. Upal, 2014

AA Section

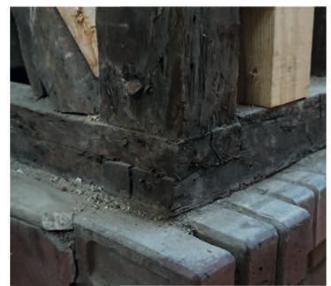
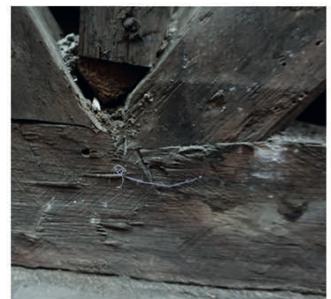
Figure 5.23: Examples of wood joints from the house in Arnavutköy

Though joints encountered in the building structure are in variety according to their usage, mainly simple methods are found and all of them are strengthened with metal nails. Primarily butt, lap and splice joints are used, but joinery of more than two timber pieces are also found. Examples from the connection methods are given in Figures 5.22 to 5.24. Additionally, types of the nails differ upon the need. For example, large iron nails are only banged to the thick load bearing elements and very thin ones are preferred mainly on the facade decorations. Besides the machine cut timber elements like cladding boards, wooden pieces shaped or cut by hand are used in the same building. Traces of hand tools are generally encountered on the structural system, which is normally non-visible to the users.

¹ All of them were photographed, documented and drawn by the author. Only the wooden parts are shown in the sketches, but it has to be stated that all the joints were strengthened by nails. Nails on all wooden joints are clearly presented at the Figures of the example in Tarabya.

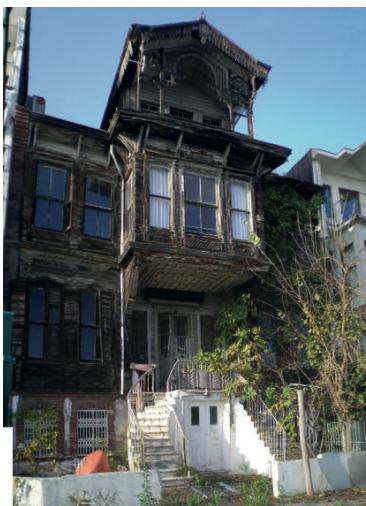
Figure 5.27: Southeast facade

During the period of construction, vehicle traffic was not intense on this neighborhood and mainly the access to the Bosphorus villages was supplied by the sea transportation. By taking into consideration that fact and the location of the building, southeast facade, which is facing the Bosphorus was designed as the frontal view (Figure 5.27).

This eye-catching facade is symmetrical with respect to the axe passing through the roof ridge and middle of the entrance door. Art Nouveau motives are collated with traditional elements. Moreover, linear pediments reflect neo-classical style and the ornaments on the top floor have similarities to the Victorian style decoration. As a consequence of the multiple influences, the building style can be described as eclectic. Besides the flower motives, basic linear forms are used on the facade decoration too. The wooden figures on the facade are generally comprised of multiple units and nailed directly to above the cladding boards like the other ornamented houses (Figure 5.29).

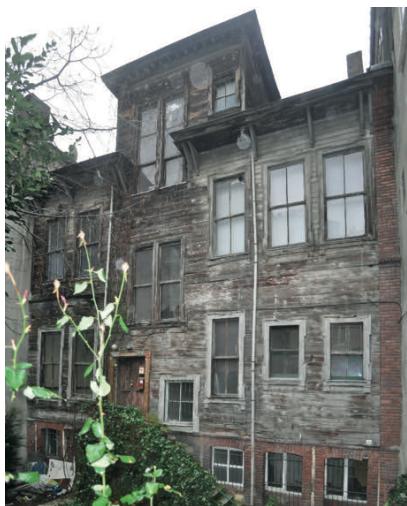
Figure 5.28: Northwest facade

Northwest facade is partly visible from the Yenimahalle Avenue through the trees on the back yard (Figure 5.28). However, it is extremely different from the seaside facade with simple and asymmetrical decoration. Also, the influences of Art Nouveau style cannot be perceived from this view. Flower motives, pediments or even the ornaments with basic geometric shapes are not used. The fenestration gives the impression of a disorderly layout, but almost certainly there had been few changes resulted from the need of the later users. Concrete entrance stairs was added on a later period as it is obvious from the material and style. Moreover, the entrance door, which enables the access from the backyard is non-original.

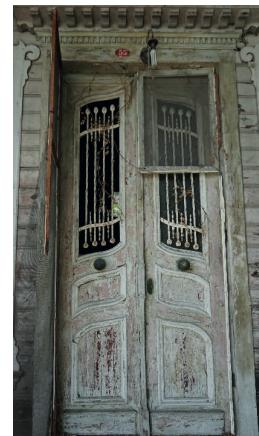
Figure 5.30: Main entrance door on the frontal facade

On the decoration of the entrance door, Art Nouveau style can be perceived (Figure 5.30). In the meantime, the usage of glass and metal with the wooden wings was one of the popular applications for the entrance doors of the summer houses of Istanbul in early 20th century. Attentive double stairs intensify the impressive look of the building

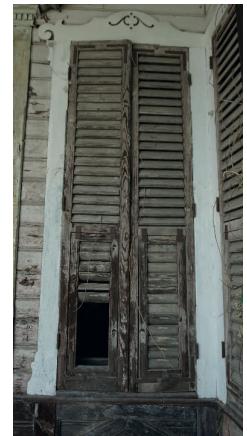
Figure 5.31: One of the windows of the first floor and the shutter

and strengthens the importance of the entrance. Additionally; moldings, decorative brackets and ornaments on the bargeboard and soffits enliven the external view. Wooden shutters are only found on this seaside facade for the first and second floor windows (Figure 5.31). Repetitive elements are apparent and the primitive machines were most likely used for the production of those components. Machine cut cladding boards are printed with lines in the middle and width of these boards are measured as 27,6 cm. In total, the building reaches approximately a height of 12.3 m at the ridge of the roof from the 0.00 level, which is assumed to be equal to the ground level of first floor.

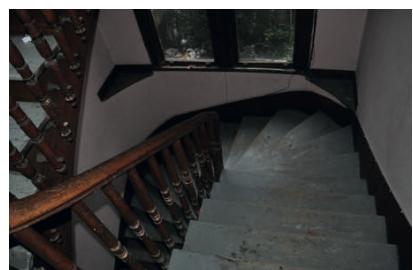
Figure 5.32: Original wooden stairs

The building has totally four stories, including the attic and the ground floor on the sea level. Formation of the house is perpendicular to the shore and the building has a type of plan with a central hall (sofa). The hall has a direct view of the sea on all floors. One double winder stairs supplies the inner circulation of the house (Figure 5.32). This authentic, wooden stairs located in line with the rooms and hall. It was designed without

any landing. The building area is approximately 132 m² without the glorious exterior stairs.

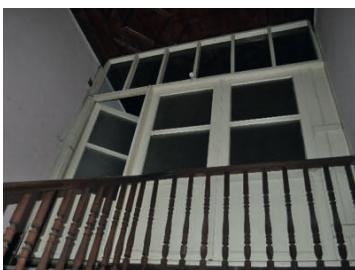
Figure 5.33: Dividing panel as a later application

These type of buildings were normally designed for the usage of one big family.¹ However, for a short period of time the building was being rented as single flats and used by different families. For this reason, few changes were made to fulfill the requests of each family. As an example, a dividing panel with a door was added to the landings of the staircase (Figure 5.33). Moreover, although it might be unnecessary for a single family usage, each floor had an independent kitchen. The building appears to be again available for a single family usage as the original design, after the current restoration work.

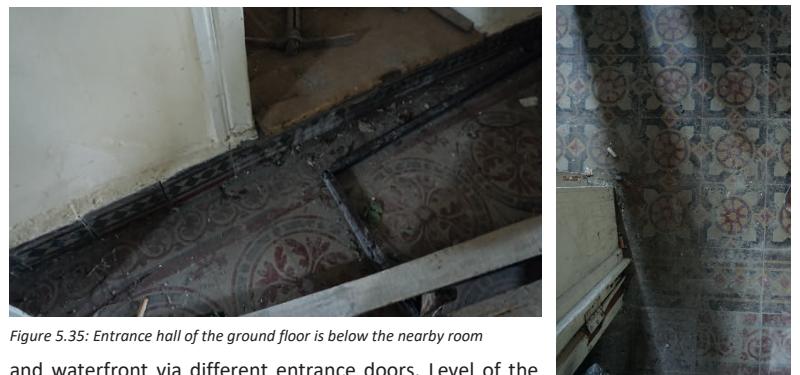
Figure 5.34: Original tiles on the ground floor

and waterfront via different entrance doors. Level of the back garden is 30-35 cm higher, while the level of the waterfront area on the other side of the house is 25-30 cm lower than the ground floor. Moreover, base elevation of the rooms also vary. The ground level of the hall is approximately 10 cm below than the nearby rooms on the southwest side and 20 cm than the northeast rooms (Figure 5.34).

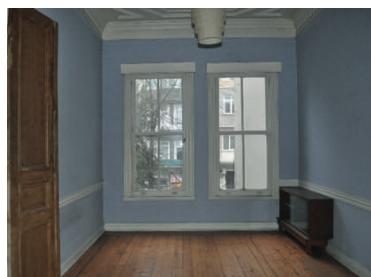
Figure 5.36: Interior

Apart from the direct access to the hall, there is a gate between two rooms on the northeast side of the building on both floors. Probably, the halls were more communal areas and this door might be used to keep the privacy of the women part. Baseboards, wooden ceiling ornaments, ceiling corner moldings, chair rails and ornamented frames of the openings are used to decorate the rooms (Figure 5.36). Like the previous wooden

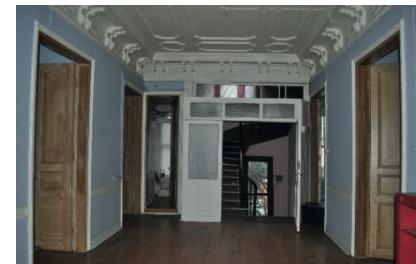
Figure 5.38: The hall of the second floor

Staircase is positioned at the same place on all floor plans (Figure 5.38). In the same way, the wet areas are also kept in the same part of the building on all floors. Wooden structured interior walls are measured 19-20 cm on both floors (Figure 5.39). The wooden exterior northeast wall is also 20 cm, while masonry southwest wall is nearly 35 cm. Thickness of the wooden floorings are 2 cm.

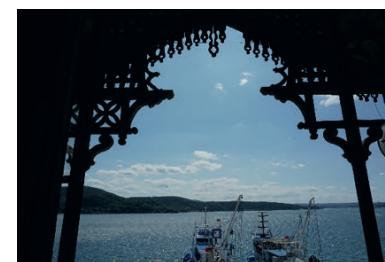
Third (top) floor: As the situation in the house of Arnavutköy, the usage area of the top floor is smaller than that of the other floors. The local description of the dashing mass on top of the house is "cihannüma", because of the perfect vision (Figure 5.40). This floor is only reached by the main interior stairs of the house. Except from the small hall, which can also be substituted for the landing, there are currently three main spaces and a balcony on the third floor. Apart from the layout, wooden construction system was also observed during the restoration work (Figure 5.41).

Figure 5.40: View from the balcony of the top floor and the decorative motives

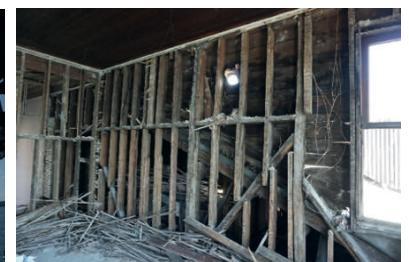
Figure 5.41: Scene from the hall of the top floor showing the ceiling and structural system of the walls.

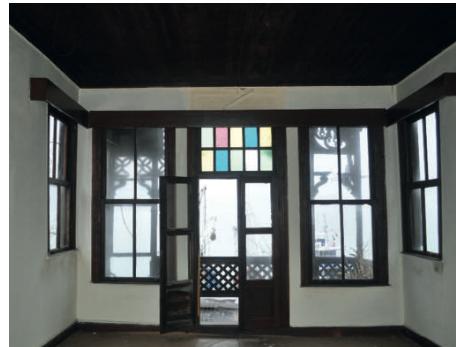
Normally, structural system of the roof is not visible on the usage areas of the house as a common tradition of the Turkish wooden residential heritage. In this direction, walls are painted with the application of bagdadi technique and ceilings are covered with thin wooden laths like the other floors (Figure 5.42). Ceiling of the main room (302) of this

floor is also decorated, but only basic linear figures were preferred. Height of this room and the small hall are nearly 305 cm by clear spacing. Two other rooms with pitched ceiling has height lowering from nearly 227 cm until 152 cm. According to Atabeyoğlu, these two rooms (301 and 303) were obtained after the roof structure was being raised. Additionally, it is claimed that the dormer windows were added later on, as the slope of the roof was changed.¹

Figure 5.42: Interior photo from the top floor

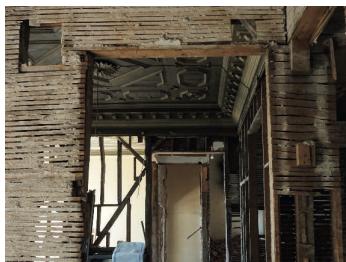
Figure 5.43: Both types of the *bagdadi* laths

Above a masonry ground floor, the building was constructed in timber frame structure. The timber frame system is used without any infill. However, few gaps between the studs were filled with brick probably as a later application. Vertical parts of the structural system are enveloped with timber broads from the outer side and "*bagdadi technique*", which is explained in detail on the previous parts, from the inner side. Two different types of the *bagdadi* technique are found in the building (Figure 5.43). On the old traditional type, the laths were split by hand; while clean cut, thin pieces were used for the other *bagdadi* lath style. Ceiling decoration and floor boards cover the horizontal structural elements such as bearer and joists. It has to be specified that three types of floorings are found. Firstly, jack arch slab consisting shallow brick arches spanning between steel beams is used on the ceilings of the service spaces (Figure 5.44). Secondly, wooden beams placed above the metal I profiles with a right angle are seen on the bathrooms (G08, 106, 205). Last but not least, traditional type of flooring with wooden beams and joists are found as the main flooring system on the whole construction.

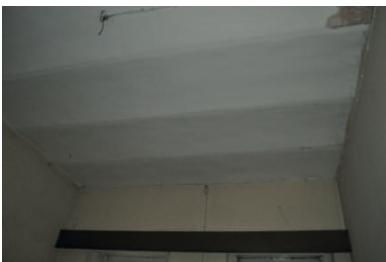
Figure 5.44: Jack arch system

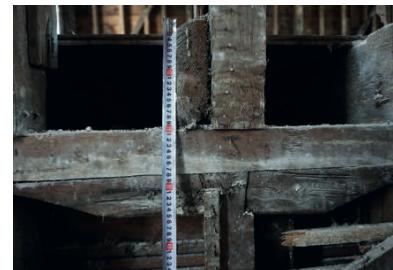
Figure 5.45: Cushion beam

to the deterioration or dislocation throughout the years. Loadbearing posts are generally placed on the same vertical axe. Minor deviations (up to 2 cm) are trivialized after strengthening the posts with small cushion beams (Figures 5.45 and 5.46). Probably, the localization of the noggings and all the non-loadbearing studs was decided on site by rule of thumb. Load bearing posts are placed on the axes of the walls, as well as all the corners. They are among the thickest timber components of the structural system and made of oak, which is a hardwood. Measured dimensions of the posts are given below in the Table 5.5.

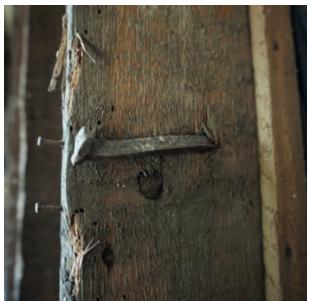
Figure 5.47: Recycled timber piece

Usually basic methods are found on the joints and they are always strengthened with nails. Types of the nails differ by the need like the other wooden houses. Similar to the previously investigated house in Arnavutkoy, large iron nails are banged to the thick load bearing elements and very thin ones are being preferred mainly on facade decorations. Additionally, several useless large nails are encountered on the timber elements of the

structural system (Figure 5.47). It proves the usage of recycled timber pieces for the nonvisual parts of the house. Moreover, traces of hand tools are also found on the structural system, but the visible surfaces are well shaped. It is quite obvious that the cladding boards are machine cut.

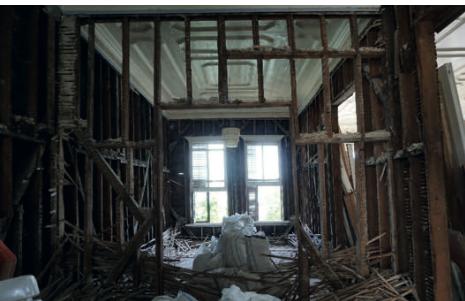
Figure 5.48: Constructive wooden elements of the walls

As in the other selected houses, wood shows up as the dominant material on the whole of the structure. Most of the architectural elements, as well as the constructive components are from timber (Figure 5.48). While all the load bearing components are from oak, other structural elements were made of pinewood. Metal appears rarely on the building. Grates of the ground floor windows, balustrades of the exterior stairs, I profiles of the jack arch and the decorative bars on the entrance door are examples of the metal elements. Brick is found on the ground floor walls, chimney and the fire wall. "B * I" is found as the stamped mark on some of the bricks (Figure 5.49). Like the house in Arnavutkoy, industrially made clay roofing tiles¹ cover the roof. Besides the common transparent glasses of the windows, colored glasses are encountered on the fixed windows of the top floor.

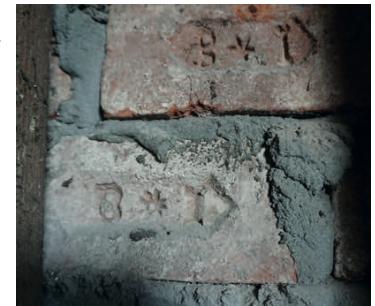
Figure 5.49: Bricks with special mark
